NASA CR-72485
PWA FR-3040

FINAL REPORT

FLOX/METHANE

PUMP-FED ENGINE STUDY

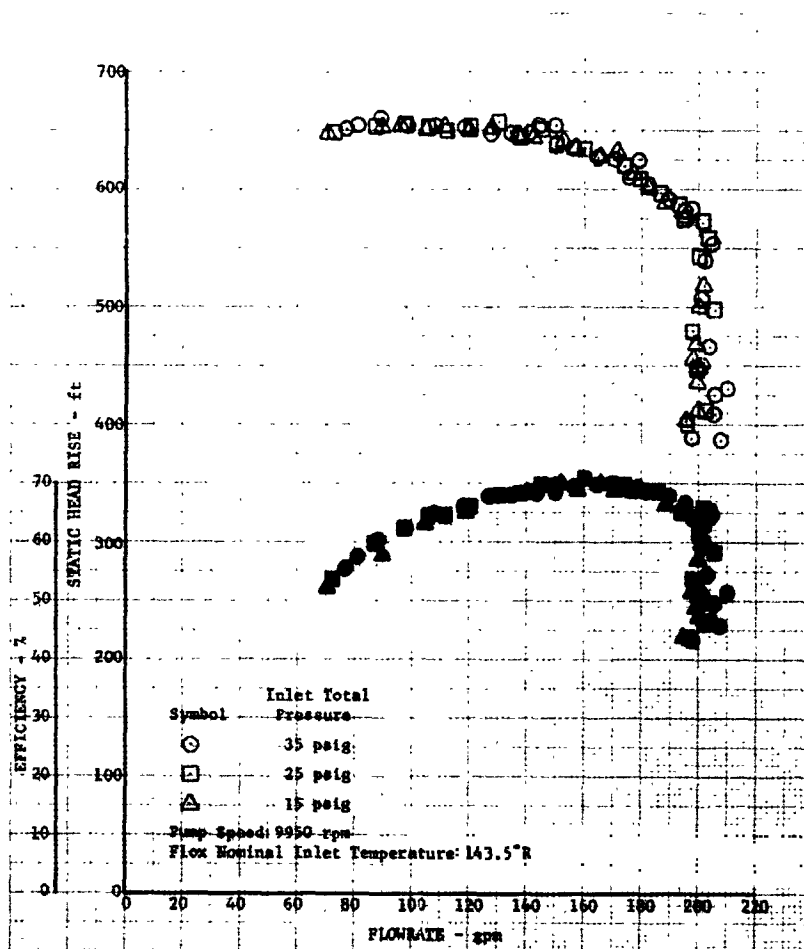
Figure 48. Performance Data From 34-Minute Flox Pump Performance and Durability Demonstration (Pump S/N C71Y002) DF 68908

Performance data obtained during four flow executions from 80 to 210 gpm at 9950 rpm with inlet pressures of 15, 25, and 35 psig are presented in figure 48. The pump was found to be in generally good condition during disassembly and inspection following the 34 minute test, but one discrepancy was noted. The K-162B primary flox seal mating ring had developed a hairline radial crack.

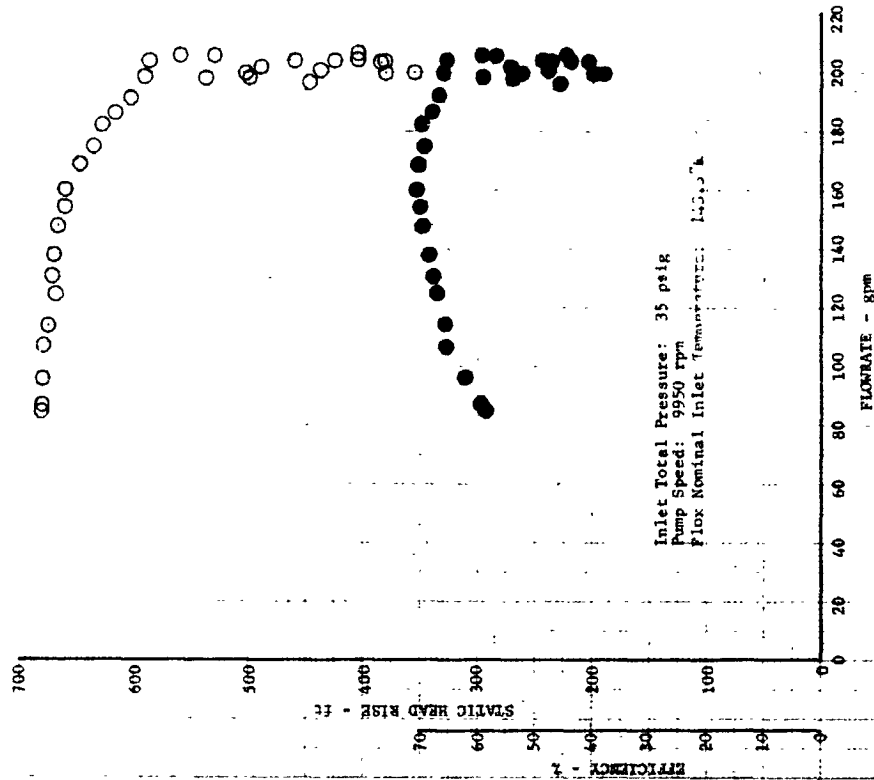
Figure 50. Performance Data From Flox Pump
Checkout Test: Pump S/N 71Y002

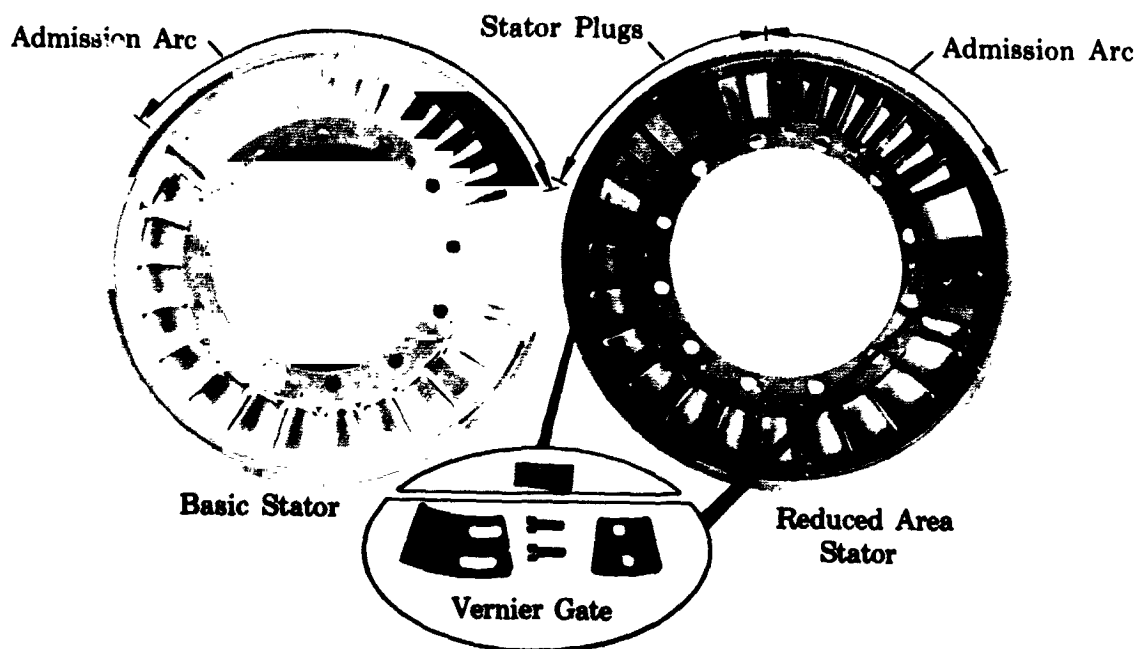
Figure 51. RL10A-1 1st-Stage Turbine Stator Area Reduction

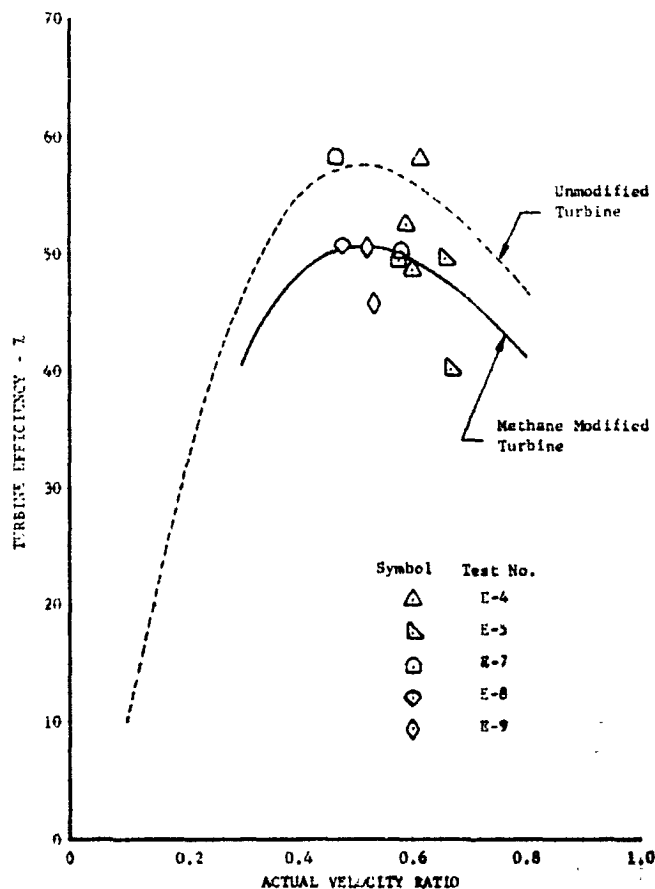
Figure 54. Efficiency of Methane Modified RL10A-1 Turbine

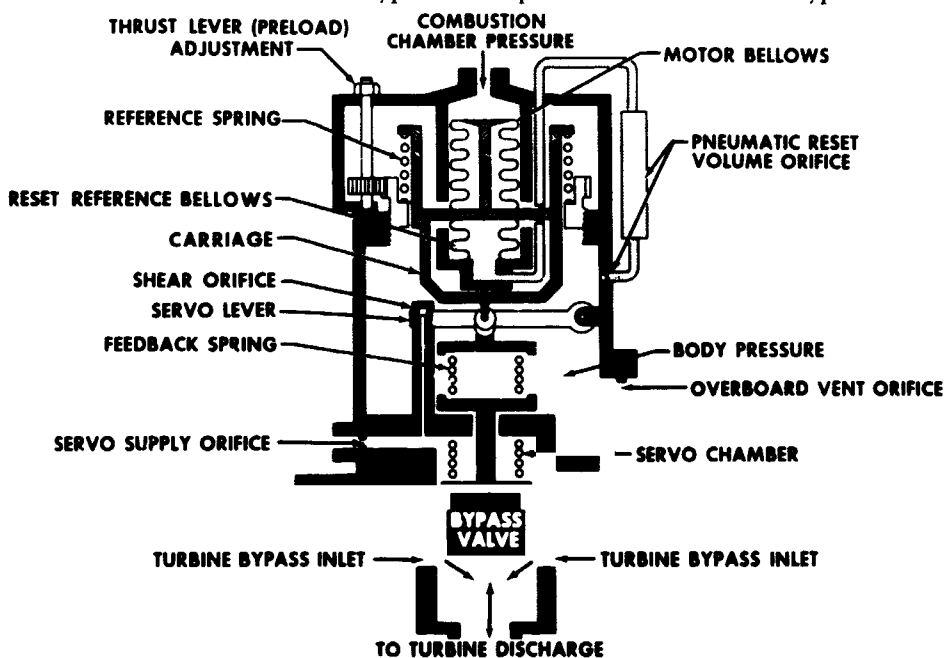
Figure 55. Thrust Control Schematic

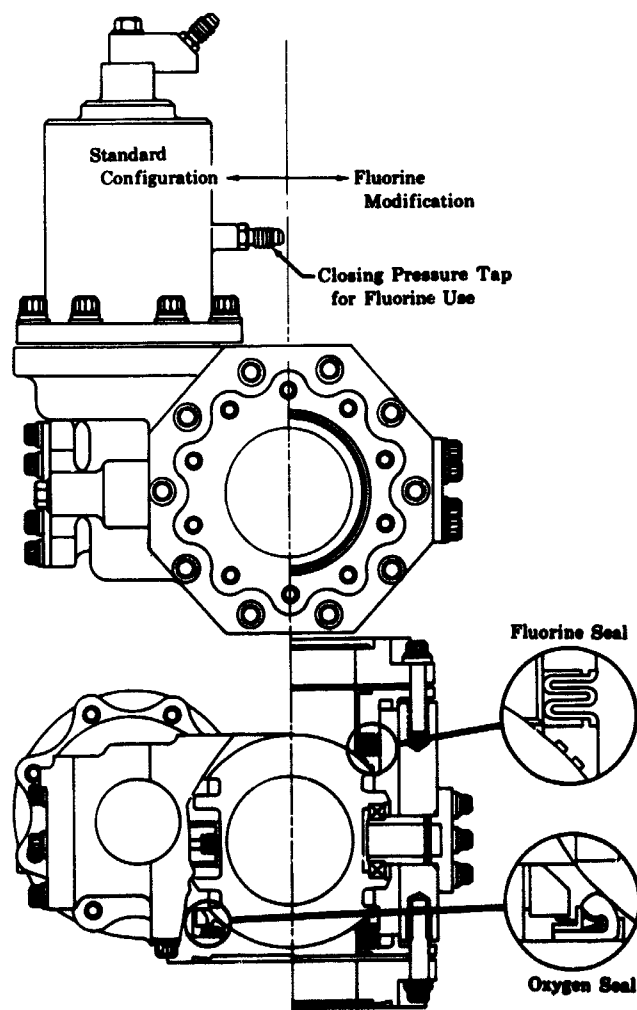
Figure 57. Oxidizer Inlet Shutoff Valve

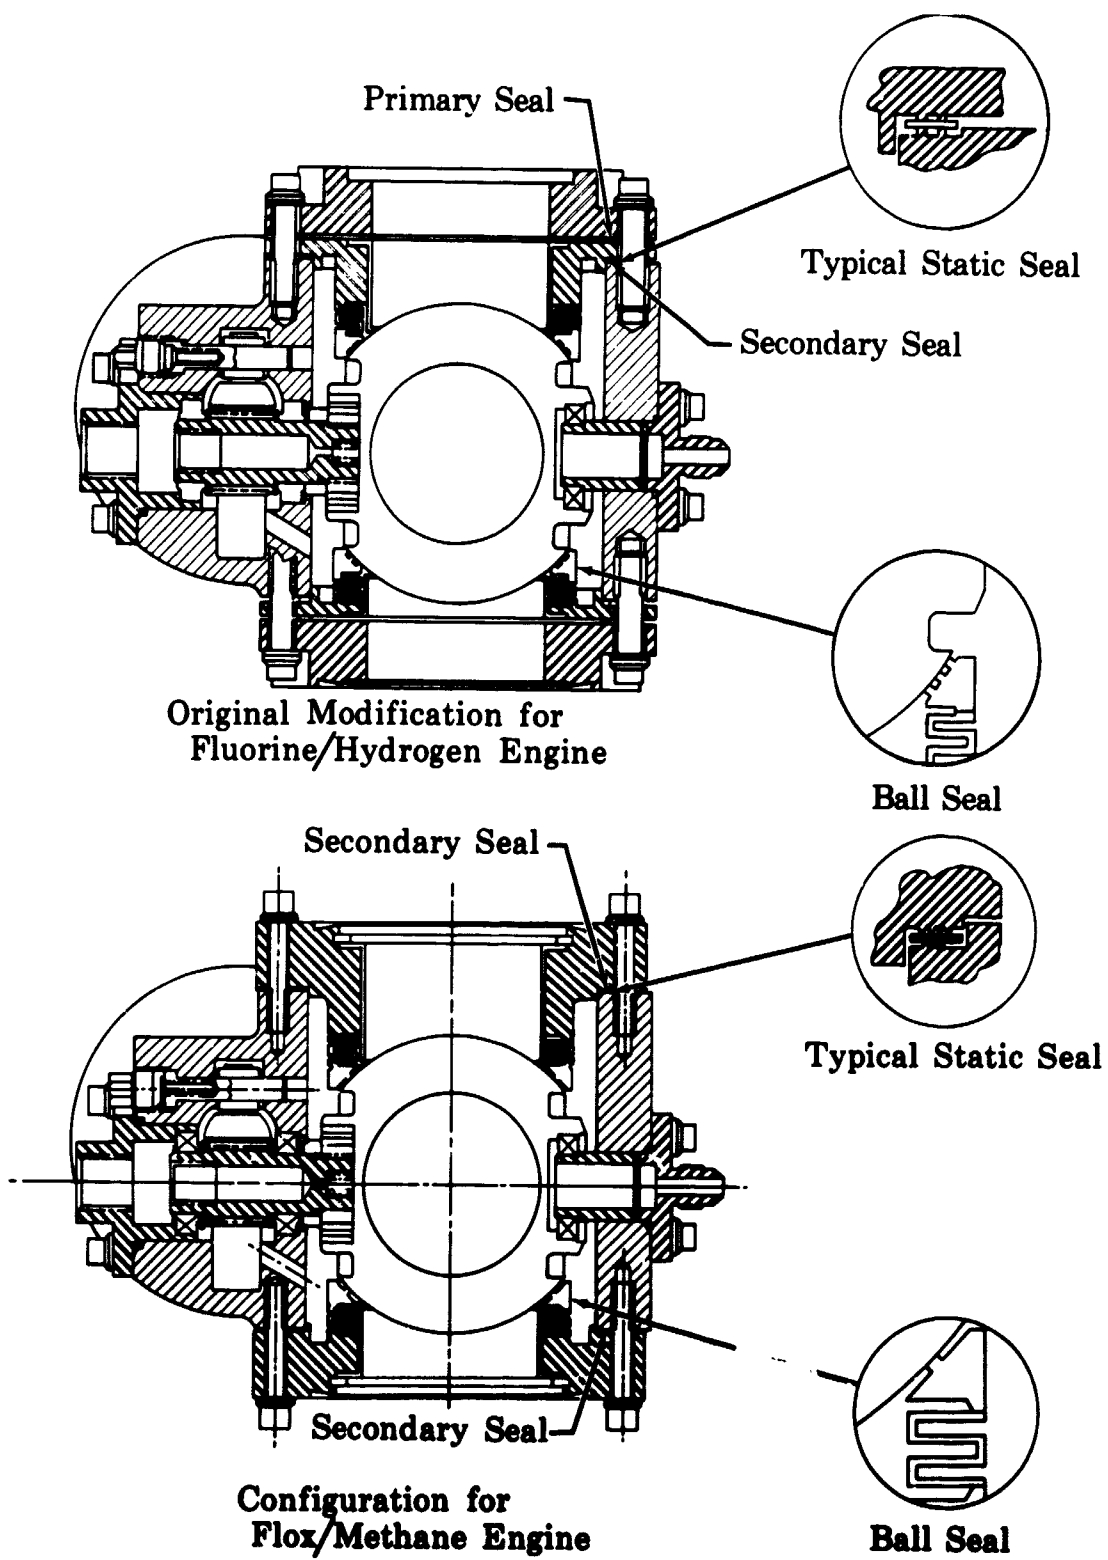
Figure 38. Oxidizer Inlet Shutoff Valve Showing Original Fluorine Configuration and Improved Configuration

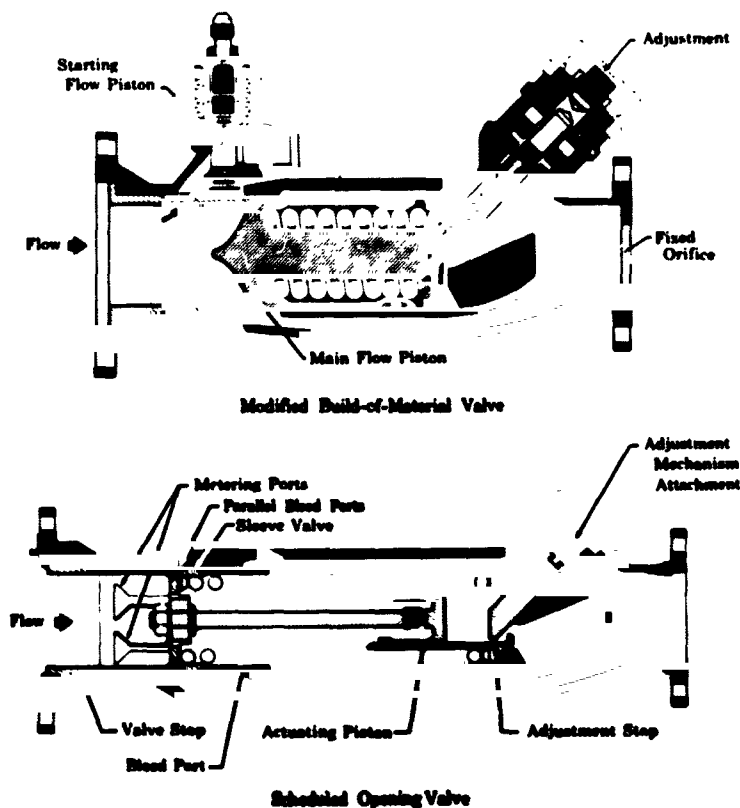
Figure 59. Modified Oxidizer Flow Control Valves

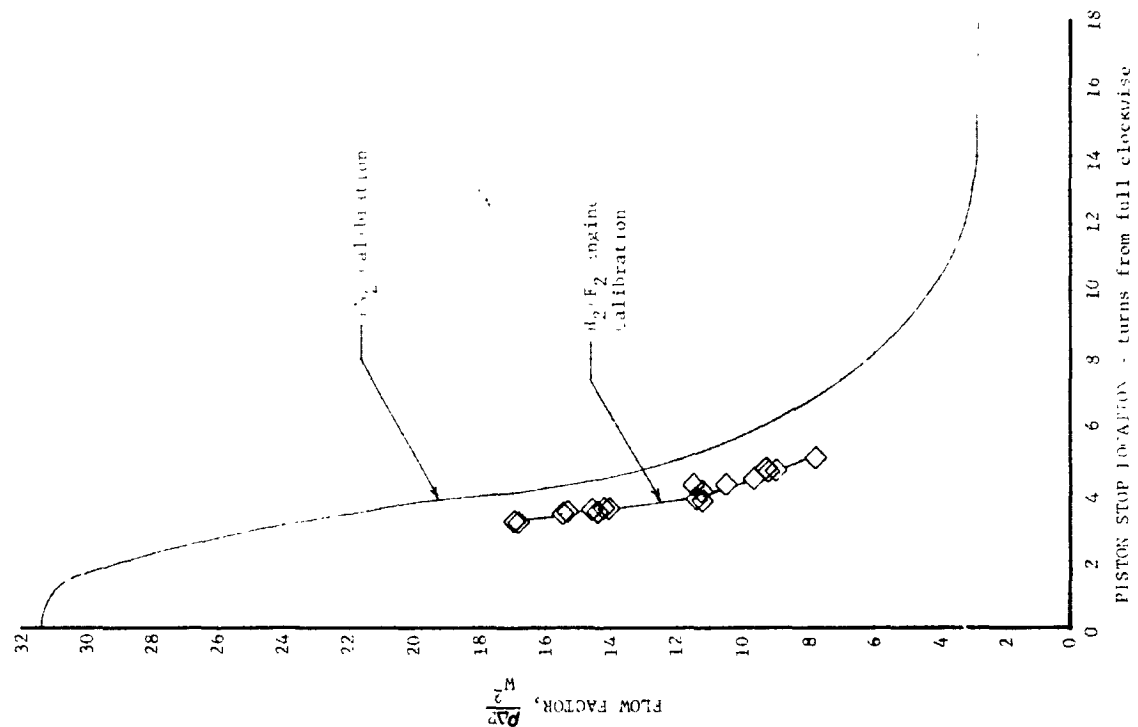
Figure 61. Oxidizer Flow Control Valve S/N C52Y001 Full Open Adjustment Calibration DF 69050

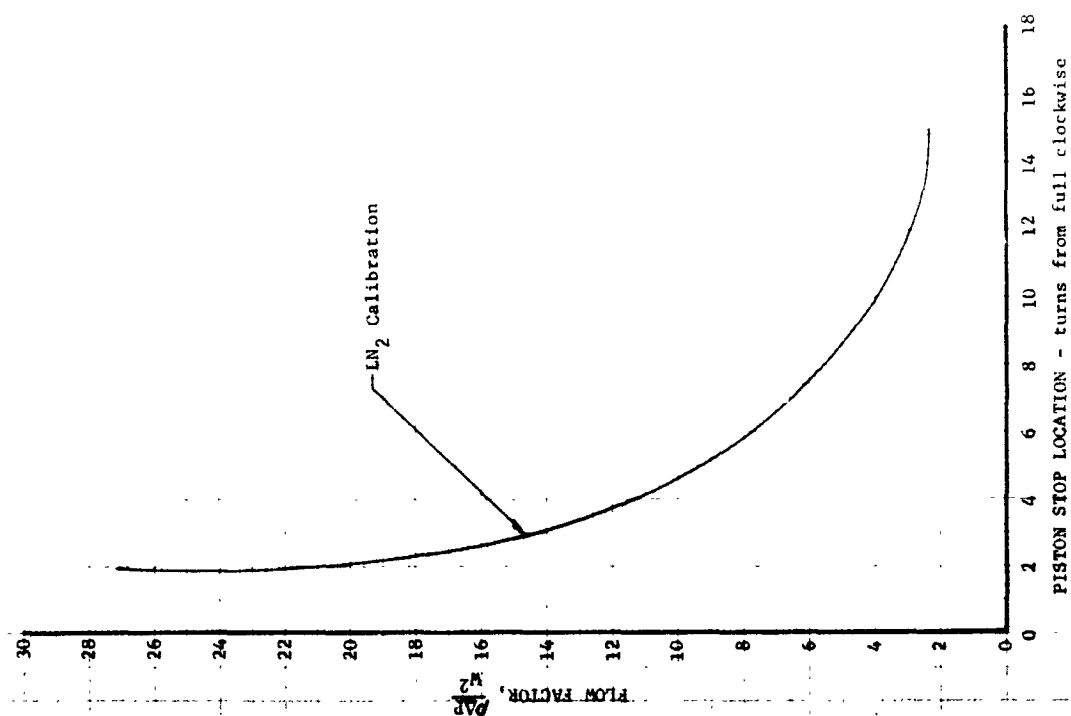
Figure 60. Oxidizer Flow Control Valve S/N C51Y002 Full Open Adjustment Calibration DF 69054

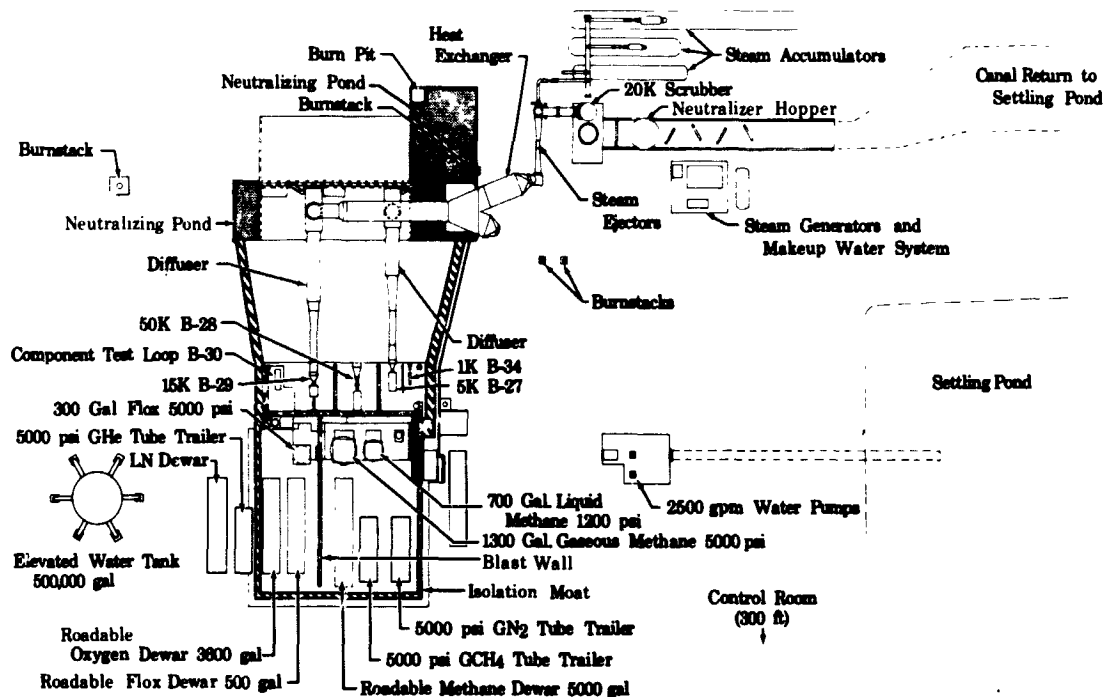
Figure 63. Liquid Propellant Research Facility Schematic

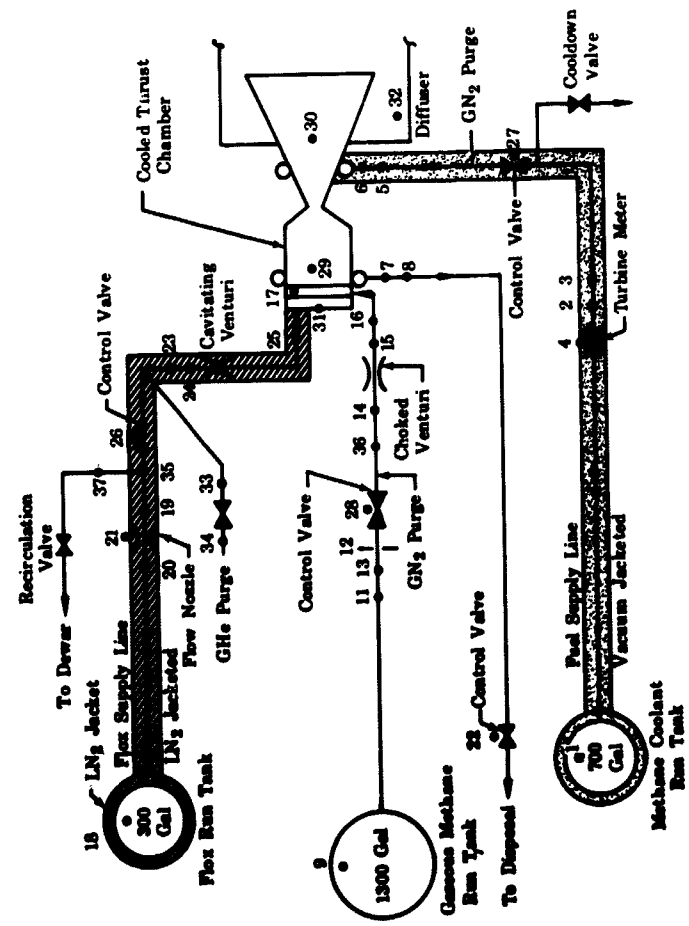
Figure 65. Propellant Flow Schematic for Separately Cooled Tests

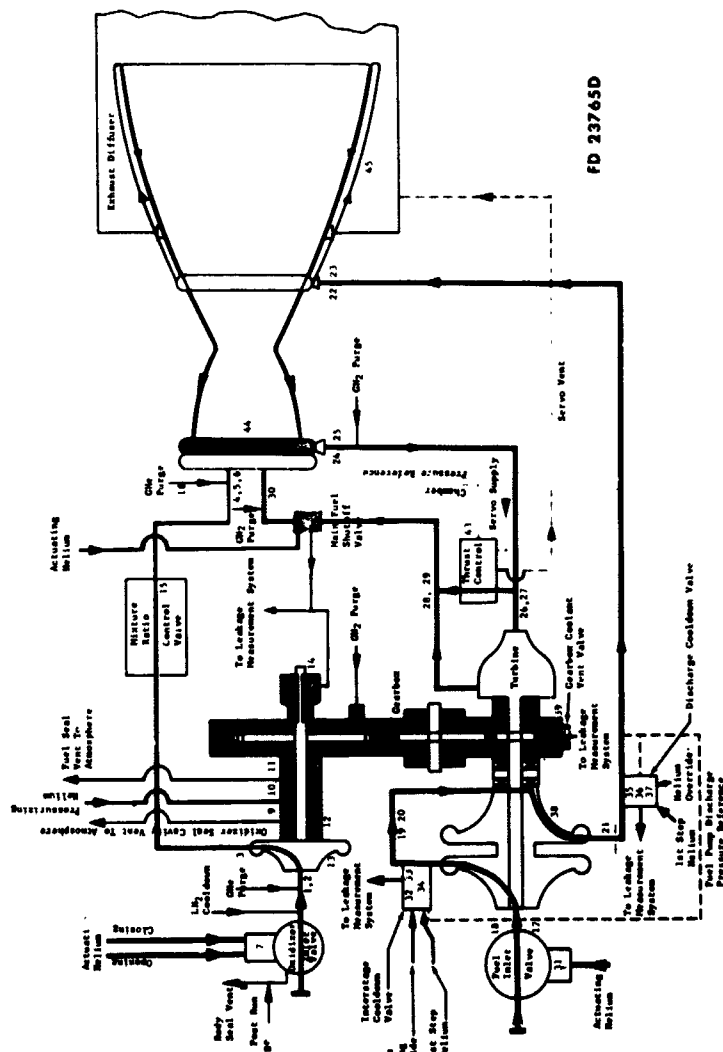
Figure 70. Flox/Methane Engine Instrumentation Locations

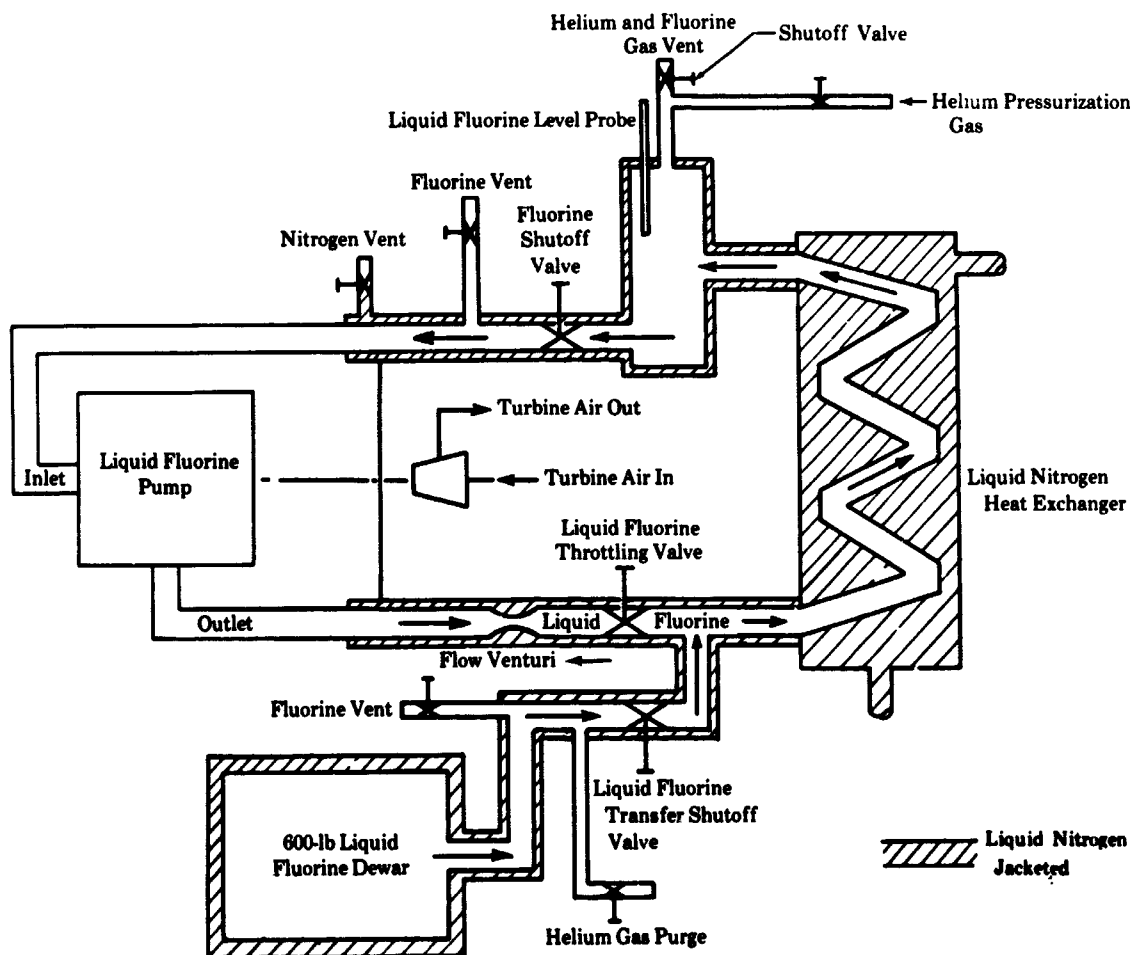
Figure 73. NASA Liquid Fluorine Pump Loop Facility

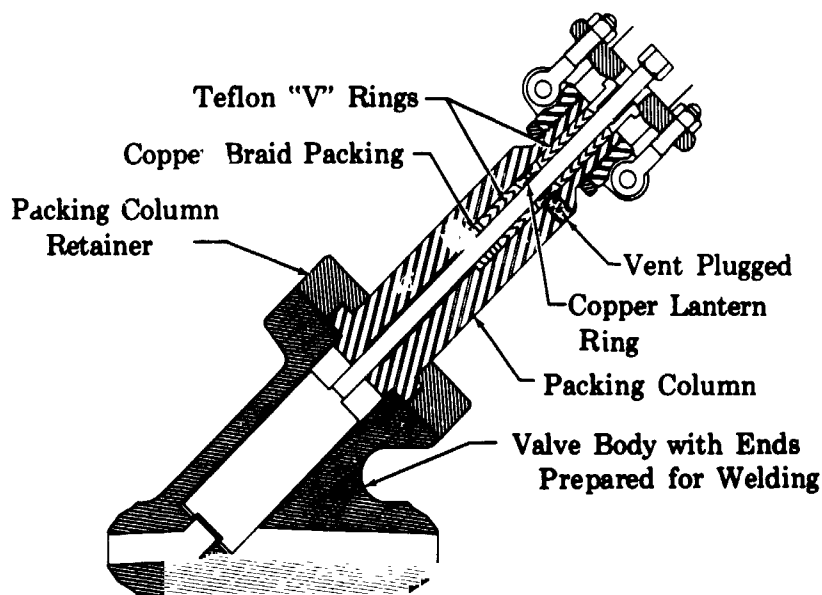
Figure 7+. Liquid Fluorine Facility Valve

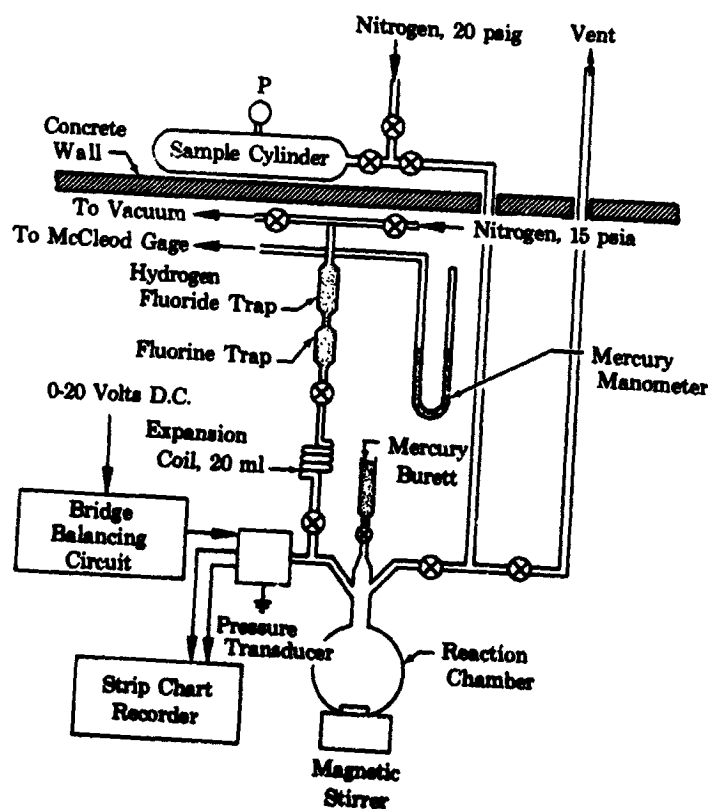
Figure 75. Schematic Diagram of Mercury Absorption Apparatus

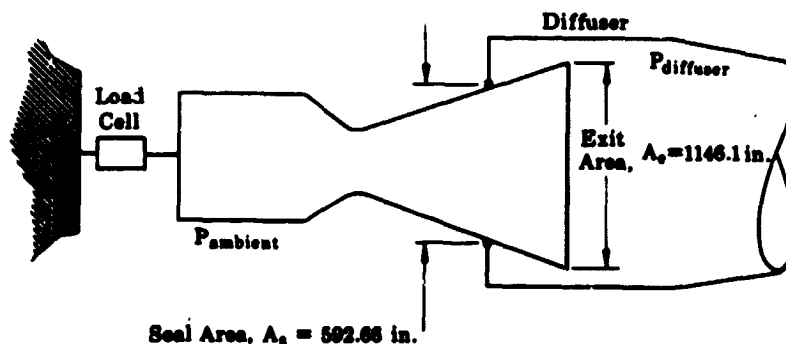
Figure 76. Schematic Diagram of Chamber-Diffuser Installation

$$F_{vac} = F_{meas} + P_a A_e + P_{diff} (A_e - A_s) \quad (B-2)$$

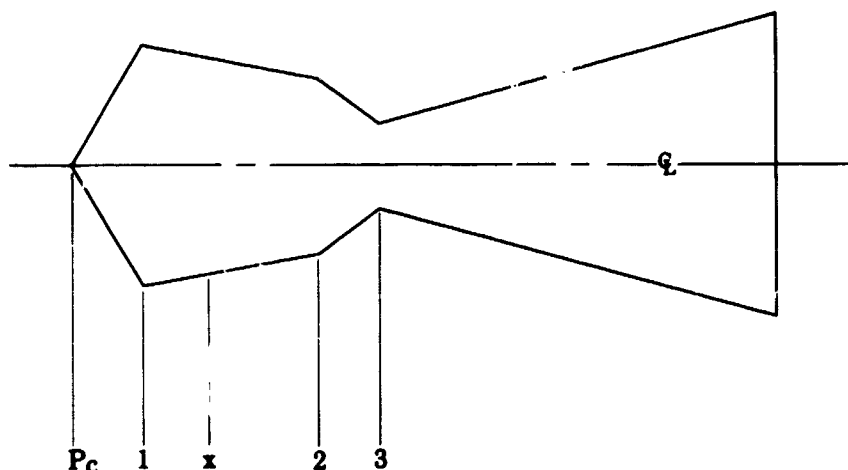
Figure 77. Stations Used in Momentum Loss Calculation

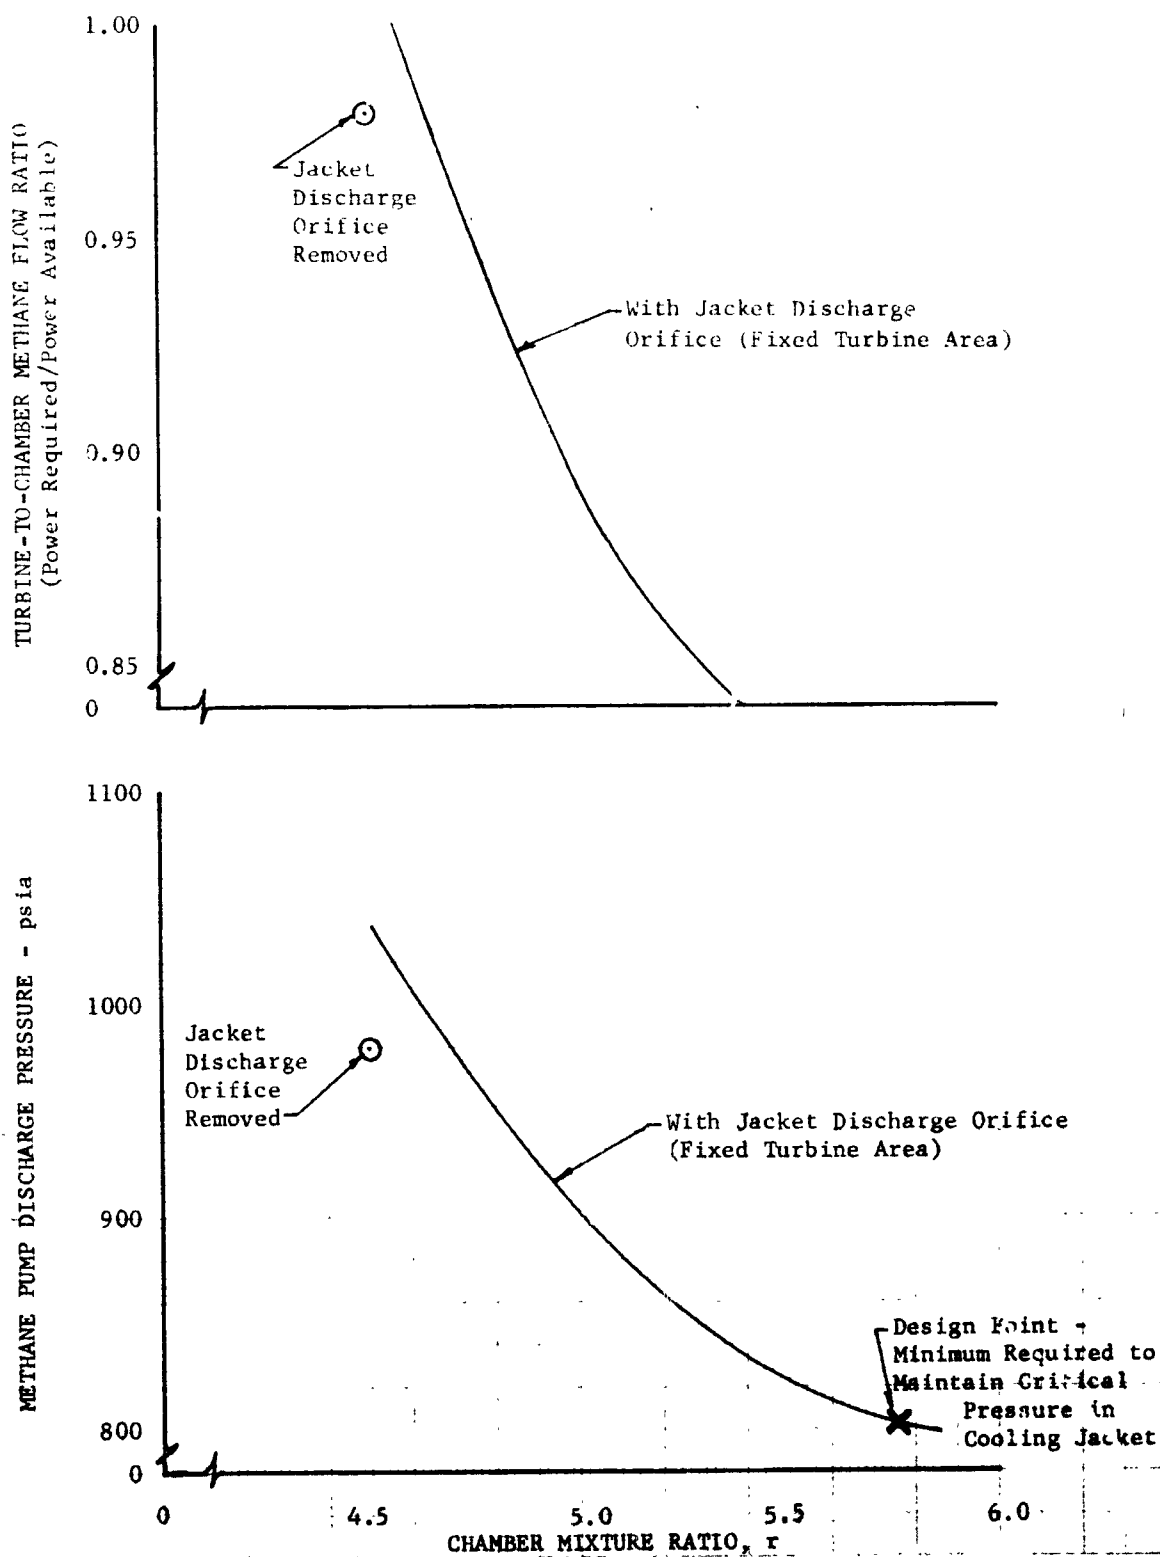
Figure 79. Variation in Cycle Paramet with Mixture Ratio

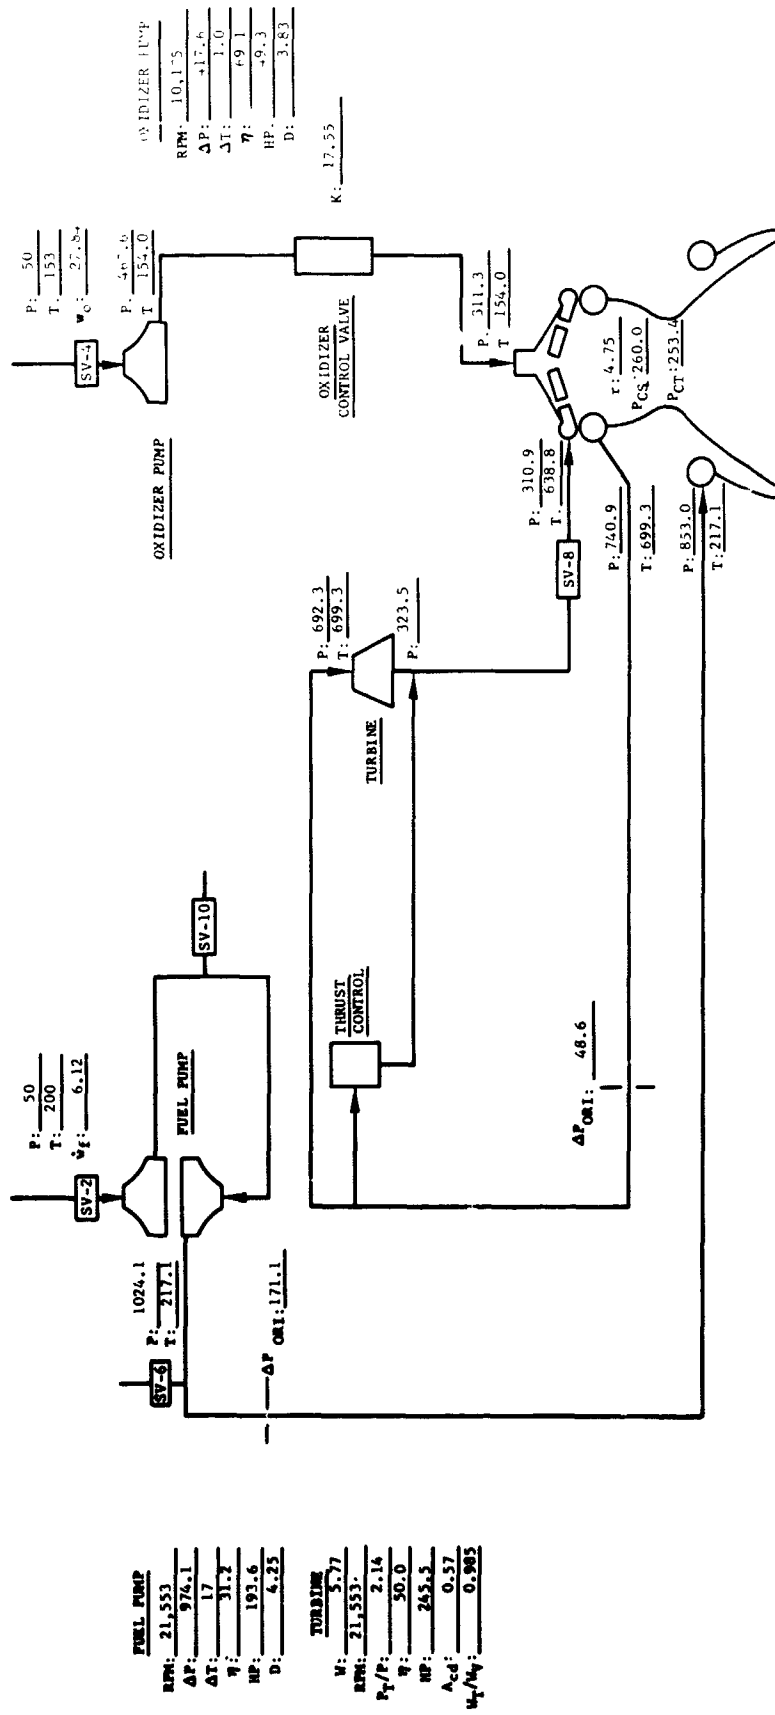
Figure 81. Cycle Balance for Final Configuration of Build No. 4; $\tau = 475$

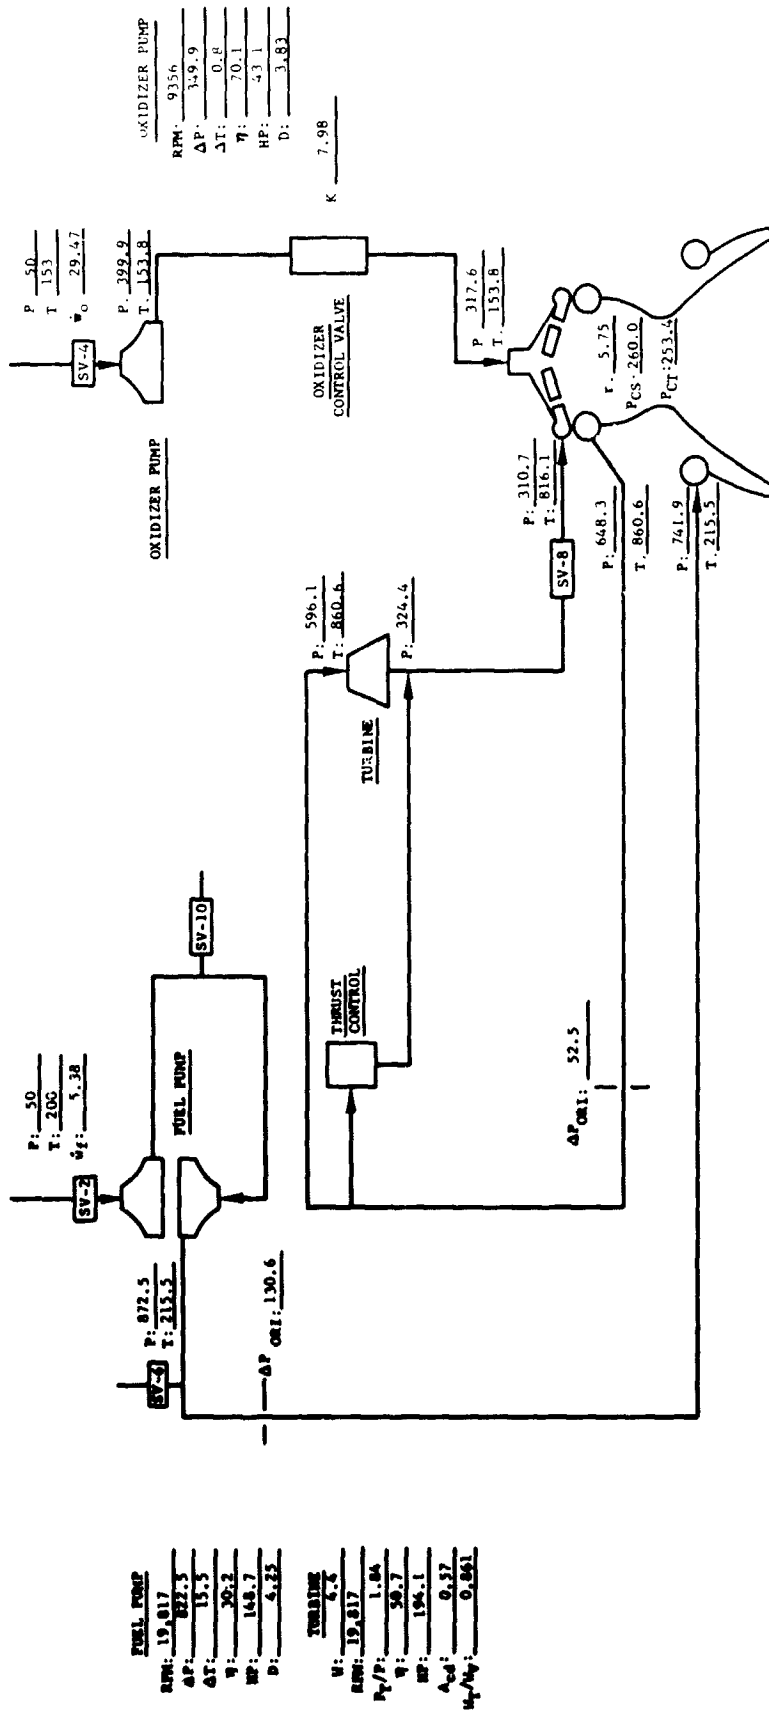
Figure 83. Cycle Balance for Final Configuration of Build No. 4; $r = 5.75$

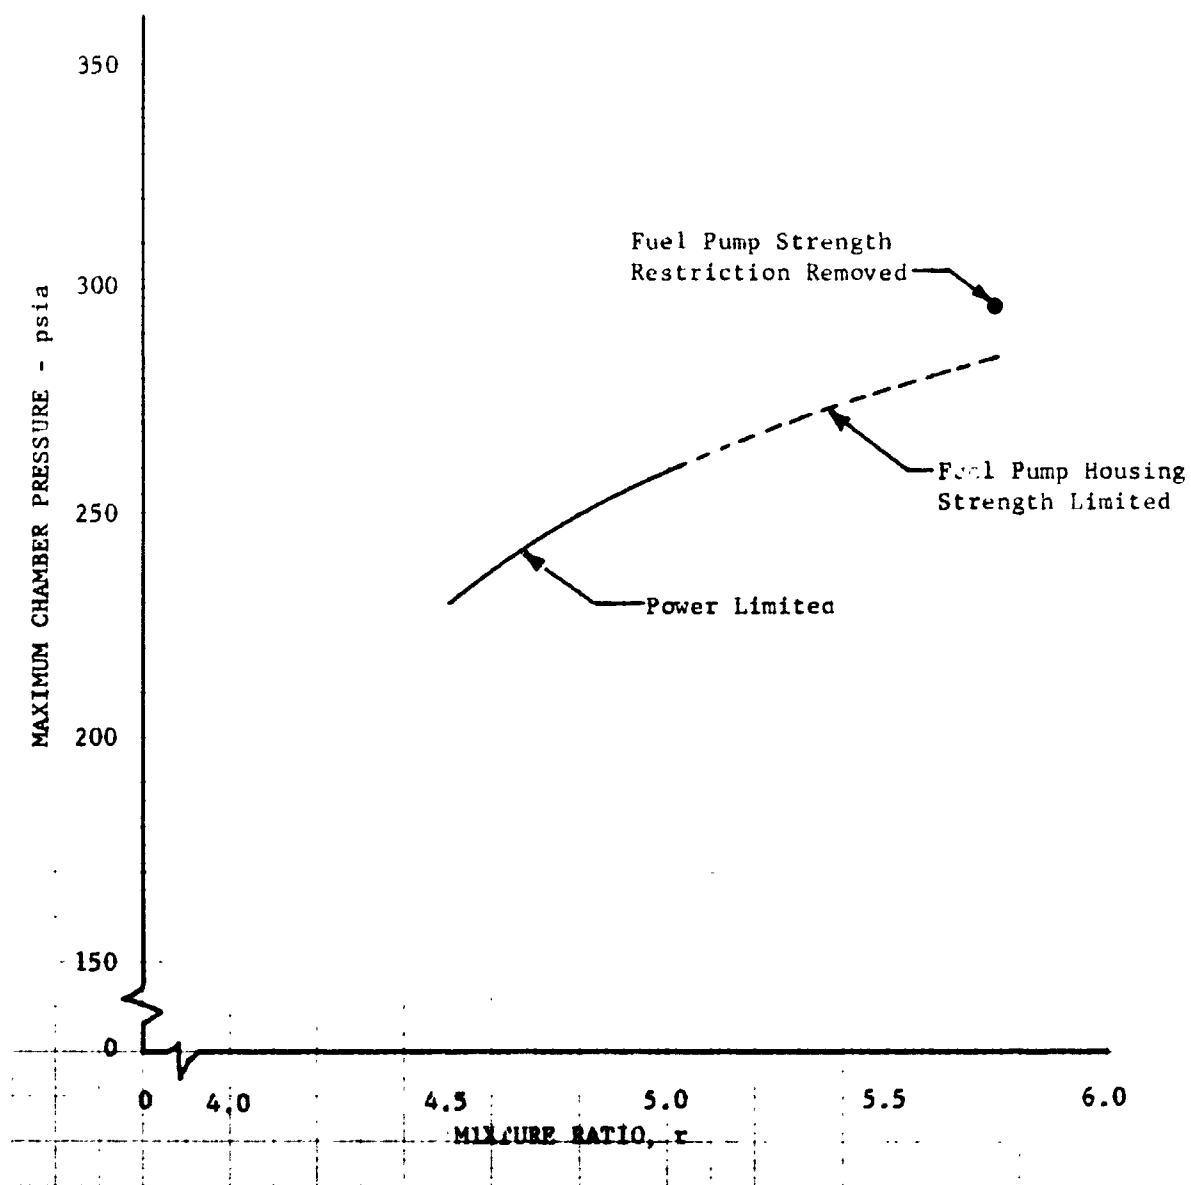
Figure 84. Maximum Chamber Pressure for Pretest Configuration of Build No. 4

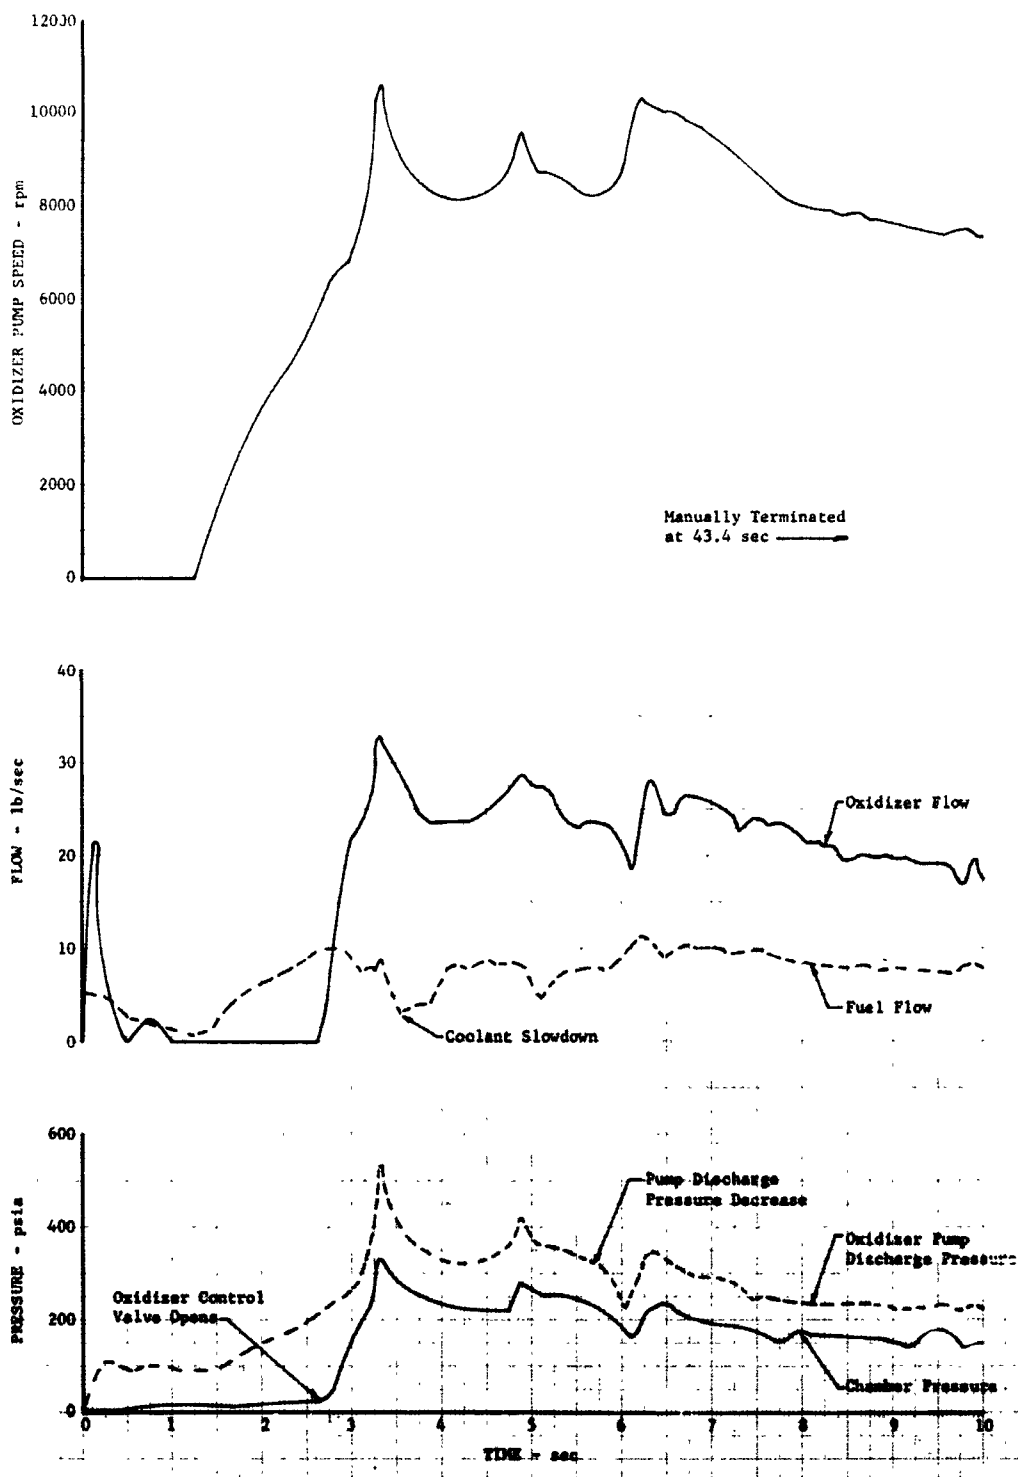
Figure 85. Starting Transient for Engine Test No. E-1

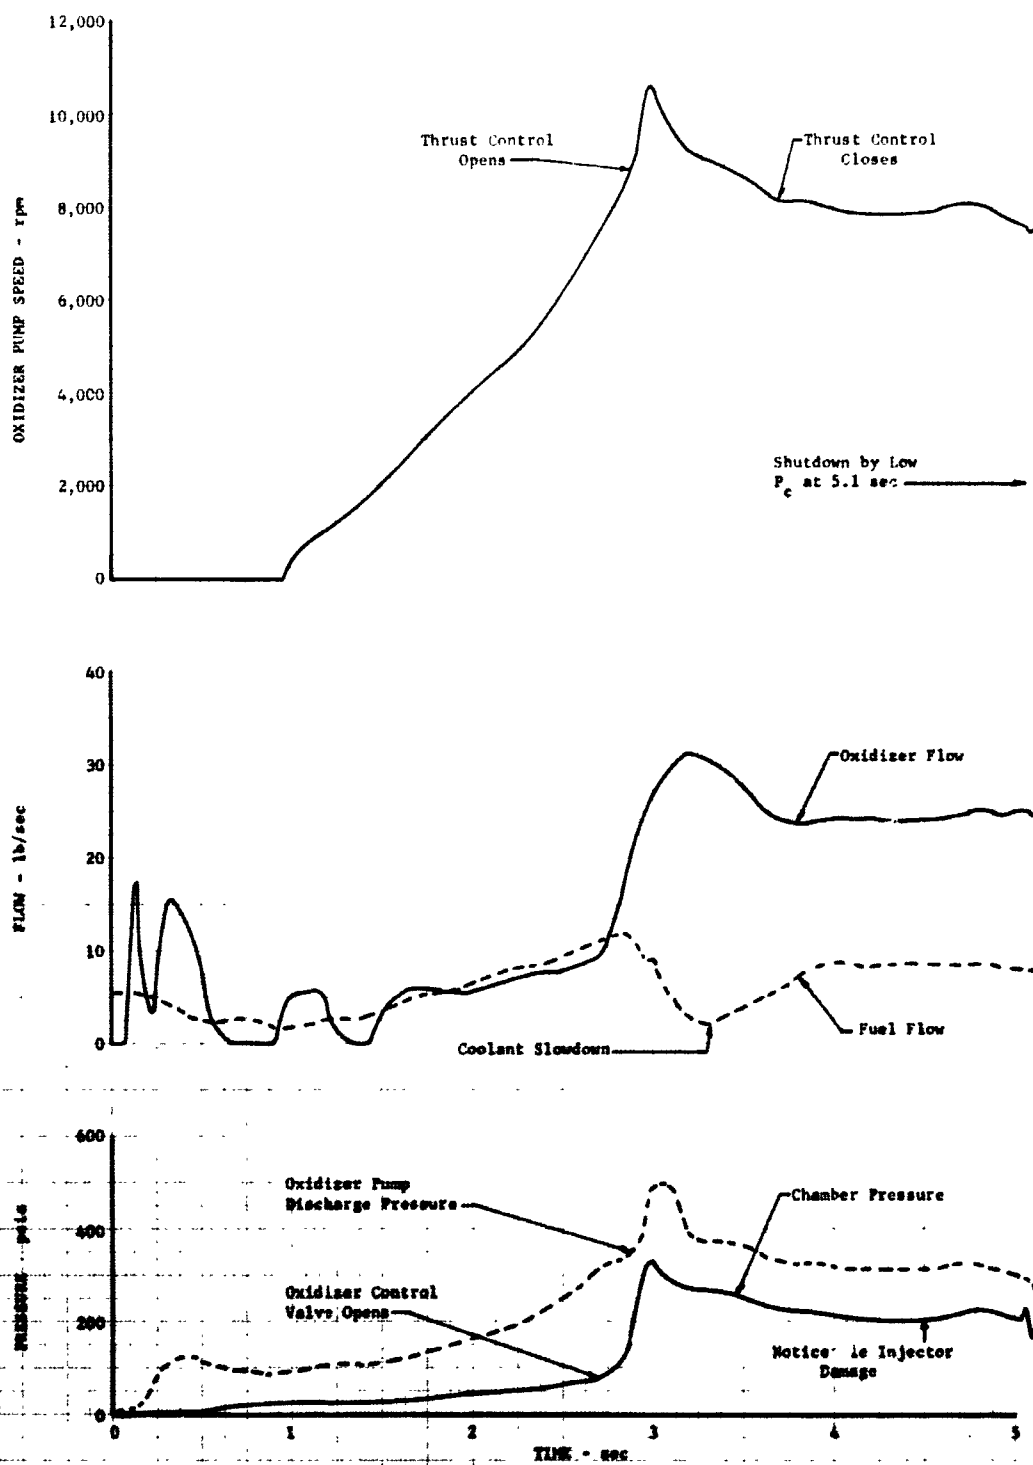
Figure 86. Starting Transient for Engine Test No. E-2
